# Maryland Historical Trust State Historic Sites Inventory Form

historic Frame house

street & number northeast corner of the intersection with Sandy Hook and Clark Roads not for publicationcity, town Sandy Hook vicinity of congressional district sixthstate Maryland county Washington

Survey No. WA III-092

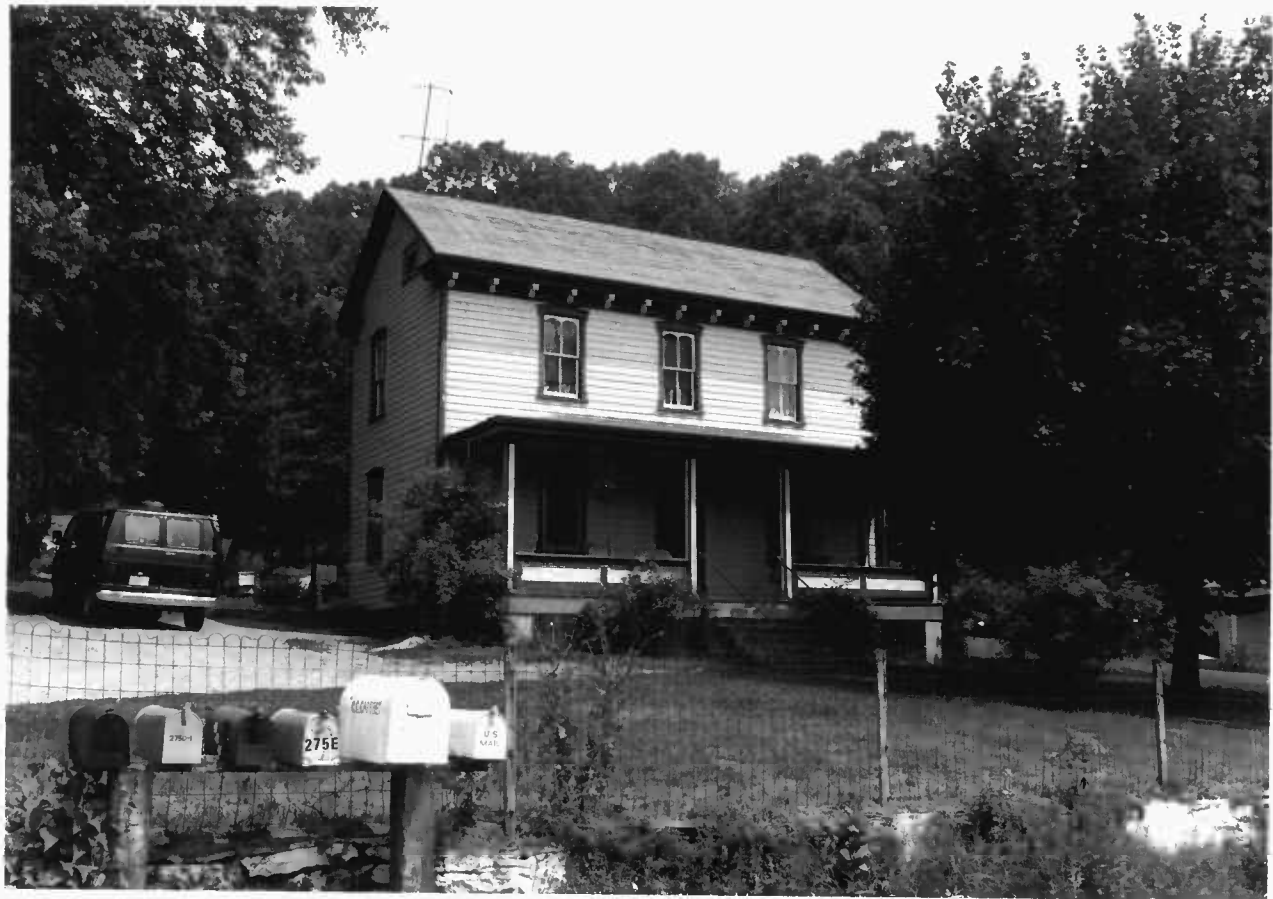
1. WA-III-092
2. Washington Co., Md.
3. Joe Getty
4. ~~April 1983~~ 7/82
5. Md. Hist. Trust, Annapolis, Md.
6. South elev. (camera facing north)
7. 1/1
